SUPERHARD TRANSPARENT COATINGS

Robert L. Fogarty, Richard S. Hassard, John Uram, Jr., Glenn E. Wintermute - Goodyear Aerospace Corporation

June 1978

Final Report for Period November 1975 - February 1977

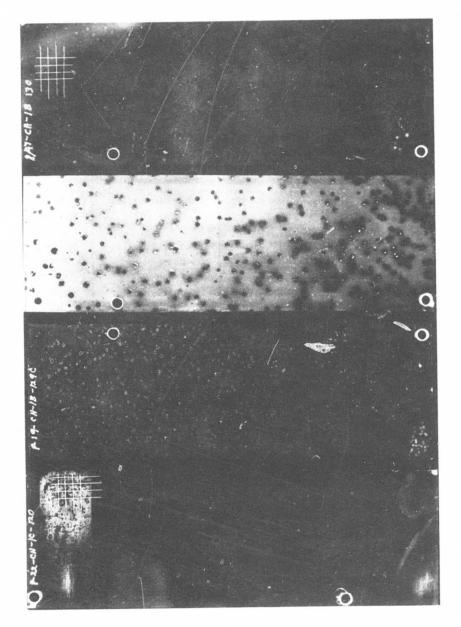
Figure 1. Coating Failures under Conditions of 95-Percent Relative Humidity, $120^{\rm o}~{\rm F}$

By placing the coatings in order of polyvinyl alcohol (PVA) content, as shown in Table 6, it appeared that the ability of the formulation to withstand the humidity exposure was contingent upon the amount of PVA being between 5 and 15 parts by weight. The 120 coating had no PVA content. A photograph of the coated specimens is shown in Figure 1.

The 129C failure consisted of massive small broken bubbles approximately 1/8 in. apart. The 130M may have been starting a similar failure mode except that cloudy spots appeared which were slightly larger and farther apart. The 120 coating exhibited an adhesive failure using the tape test of CLA-12799A, procedures "A" and "B", but did not spot. The 119 held up very well. Figure 2 shows the No. 119 coating on the control specimen and a specimen subjected to 1344 hours exposure of 120° F at 95 percent relative humidity. The light transmission and haze measurements of the control and test specimens were:

A fifth coating, 129 C/M, also failed in less than 7 hours. The formulation was the same as the 129C except for the addition of diacetone acrylamide (DAA) in a 25/5 ratio of PVA to DAA. The coating blistered in a pattern similar to the 130M coating and also exhibited a haze and metallic irridescence.

NO. 120 ADHESION FAILURE 17 DAYS

NO. 129C COATING FAILURE <7 HOURS

NO. 129C/M COATING FAILURE <7 HOURS

NO. 130 COATING FAILURE <18 HOURS

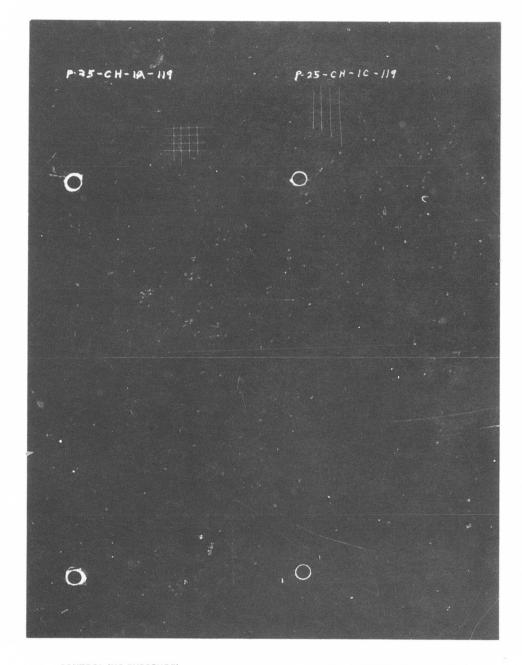
Figure 2. No. 119 Coating Subjected to 120° F and 95-Percent Relative Humidity

CONTROL (NO EXPOSURE) SPECIMEN NO. 119 COATING

TESTED (EXPOSED 1344 HOURS) SPECIMEN NO. 119 COATING

A fully hydrolyzed Elvanol 71-30G polyvinyl alcohol had been used in all the coatings subjected to the environmental screening tests of Section III in this report. Although the 119 coating was initially microcracked, it did sustain the humidity test which destroyed the other coatings containing PVA. Various hydrolyzations and viscosities of PVA's were tested for crack resistance. The object was to find a PVA which wouldn't crack initially in a higher concentration (129C coating) and could be used in a lower concentration without cracking, and also pass the humidity test.

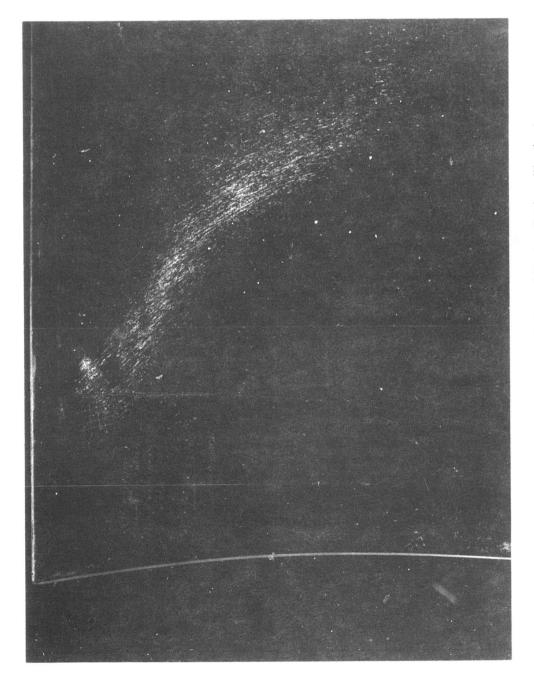
Figure 3. UH-1 Panel Coated with 129C Crazed During Outdoor Weathering

windshield was coated with the 119 material and cured. The coating had massive cracking which, in the sunlight, exhibited an unacceptable bright refraction capable of obstructing the pilot's view. A UH-1 panel coated with the 129C which was cured without cracking, but eventually crazed during outdoor weathering, is shown in Figure 3. The former had an Alon content and the latter had none.

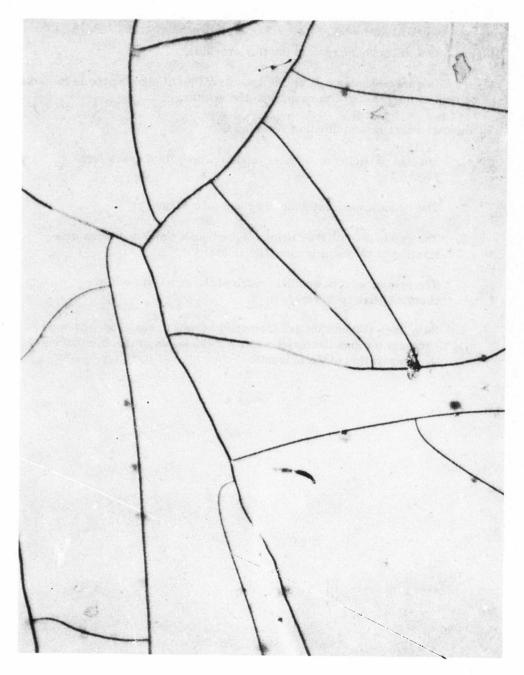
Figure 5 is a microphotograph of the fine cracking.

Figure 5. Microcracking of Parel No. 75 Modified 119 Coating with SiO₂ and Partially Hydrolyzed PVA on Stretched Plex 55 with Methyl Butynol/Ethanol/Polyvinyl Formal

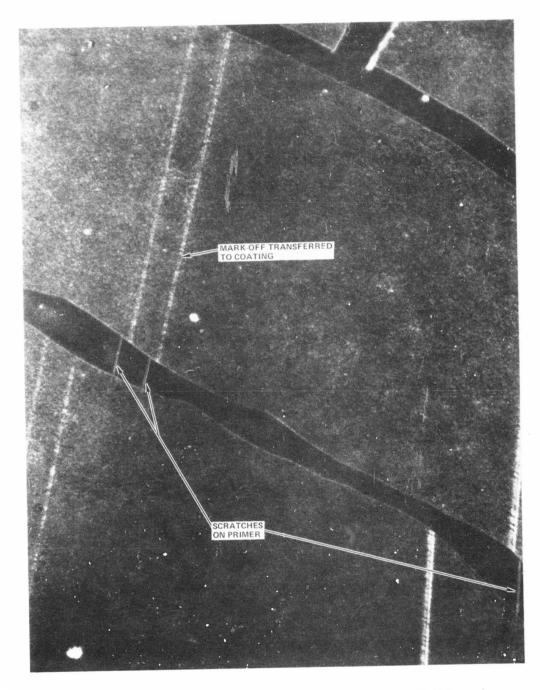
Figure 6. Flaking of Panel No. 76 Modified 119 Coating with SiO₂ and Partially Hydrolyzed PVA on Plex II Substrate and Methyl Butynol/Ethanol/Polyvinyl Formal

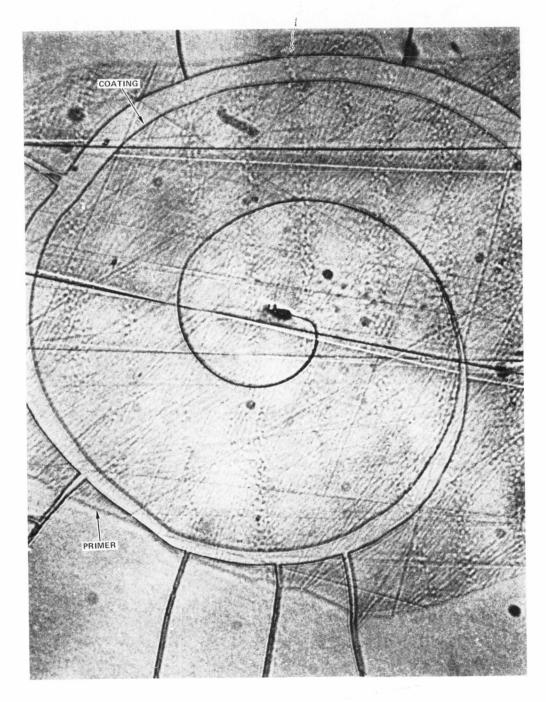
- 1. Foreign particles or bubbles tend to propagate a crack (see Figure 7).
- 2. The primer apparently did not flake (see Figure 8).
- 3. The gap between flakes being larger than a crack indicates contraction of the coating (see Figure 8).
- 4. The primer covers and fills much of the substrate surface abnormalities (see Figure 9).
- 5. Rule lines (Figure 10) are theorized as being caused by vortex currents through the cross-sectional thickness of the film during the evaporation of the solvents.

Figure 7. Propagation of Crack from Locus of Bubble or Foreign Particle

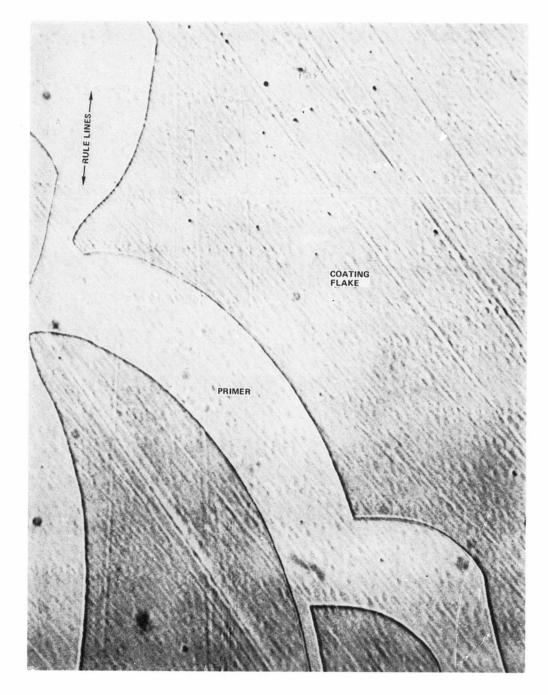
Figure 8. Microphotograph of General Flaking Showing the Primer Intact

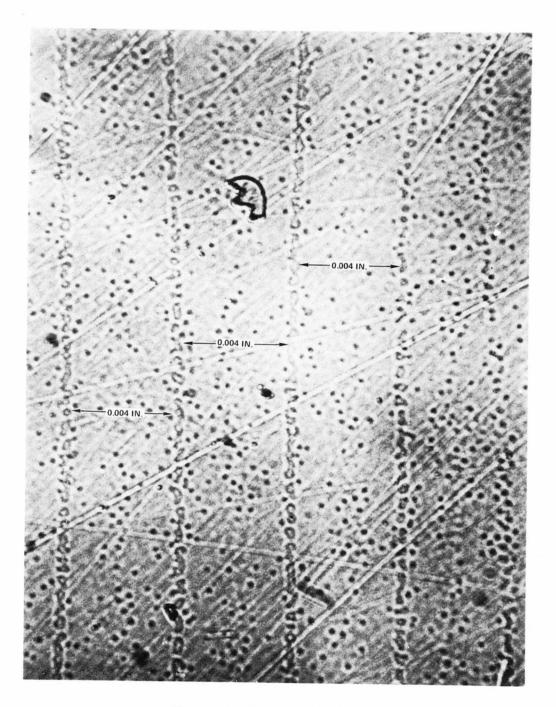
Figure 10. Rule Lines in Primer
